State of California
The Resources Agency
DEPARTMENT OF WATER RESOURCES
DIVISION OF SAFETY OF DAMS

INSPECTION OF DAM AND RESERVOIR IN CERTIFIED STATUS

Name of dam Oroville Dam Dam No. 1-48 County Butte
Type of dam Earthfill Type of Spillway Gated Concrete Weir and Chute
Water is 27.97 feet below spillway crest and 49.97 feet below dam crest.
W.S. 872.03 feet
Weather Conditions Overcast
Contacts made Kevin Dossey, OFD; Dan Garcia, Bill McLaughlin, O&M.
Reason for inspection Periodic Evaluation (2nd inspection)

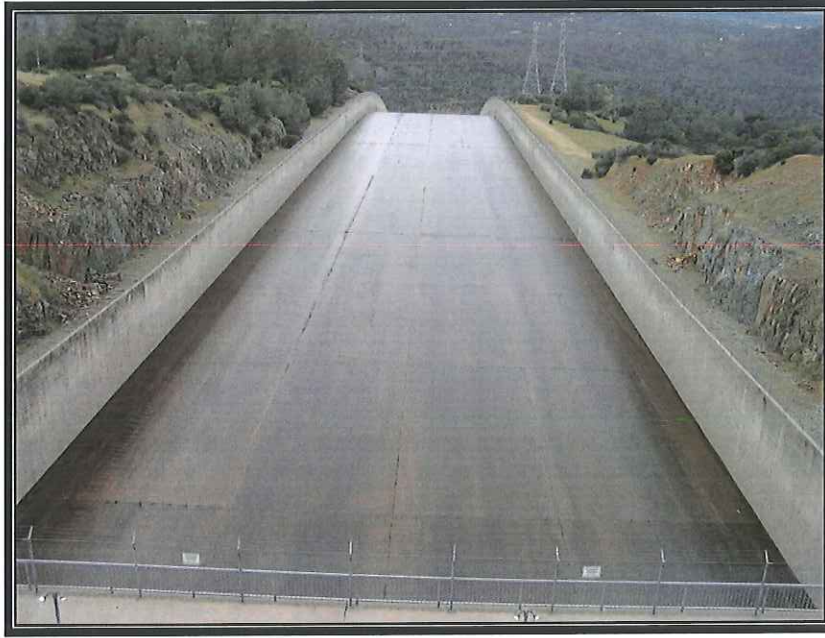
6,8,10	<p>Spillway - The spillway chute and walls were observed from several locations. The walls and chute floor appeared to be stable, and in good condition, see photograph 1. The wall</p>
Typed by <u>wmp</u>	Use Field Sheet Standard
Date <u>6/7/05</u>	Numbers and Items
cc for <u>Book/Owner</u>	(See Reverse Side)
	<p>Inspected by <u>W Pennington</u> <u>6/7/05</u> <u>HW 6/8/05</u> Date of Inspection <u>5/17/05</u> Date of Report <u>6/7/05</u> Photos taken? Yes <u>X</u> No <u> </u> Sheet <u>1</u> of <u>3</u> Sheets</p>

1. The spillway walls and chute appeared to be stable and in good condition. The wall drains beyond the vertical curve in the chute were flowing.

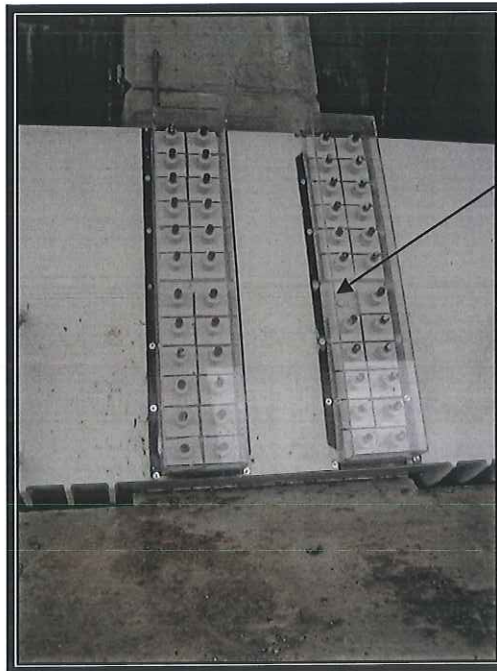
Broken tendon anchor.

2. A typical tendon arrangement for the radial gate trunnion beams is shown. An anchor that broke several years ago is shown at right. Corrosion protection is provided by the plastic covers.
